AN INVESTIGATION OF IMPROPERLY QUENCHED (SOFT) ALUMINUM PLATE

Systems Support Division Air Force Materials Laboratory

December 1979

TECHNICAL REPORT AFML-TR-79-4205

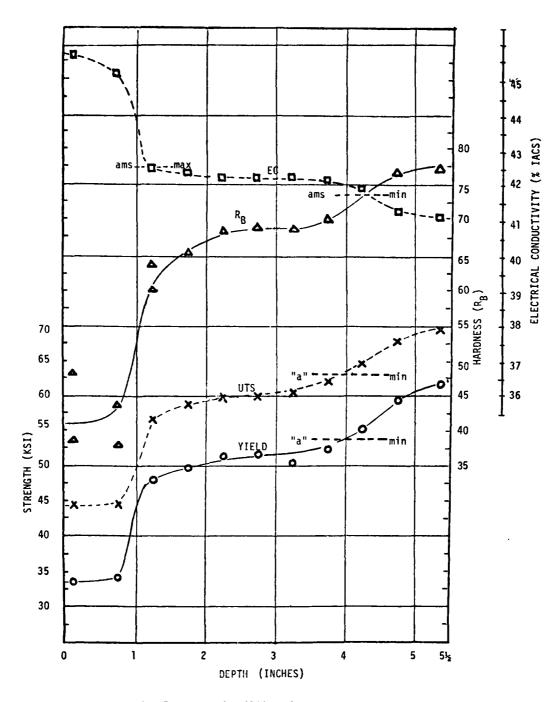
Figure 2. Test Data for 2124-T851 Aluminum Plate 5-1/2" Thick

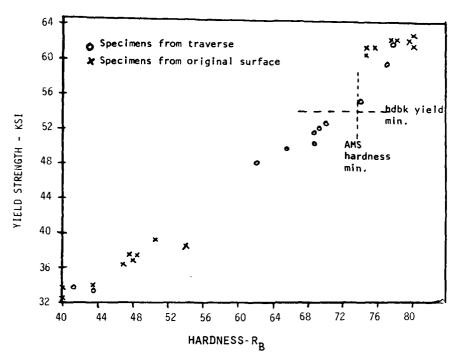
Figure 3. Hardness Versus Yield Strength for 2124-T851 5-1/2" Plate

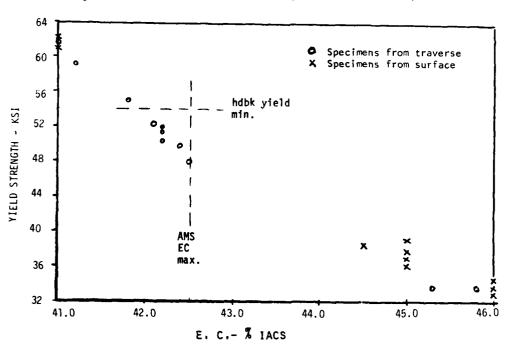
Figure 4. Electrical Conductivity Versus Yield Strength for 2124-T851 5-1/2" Plate

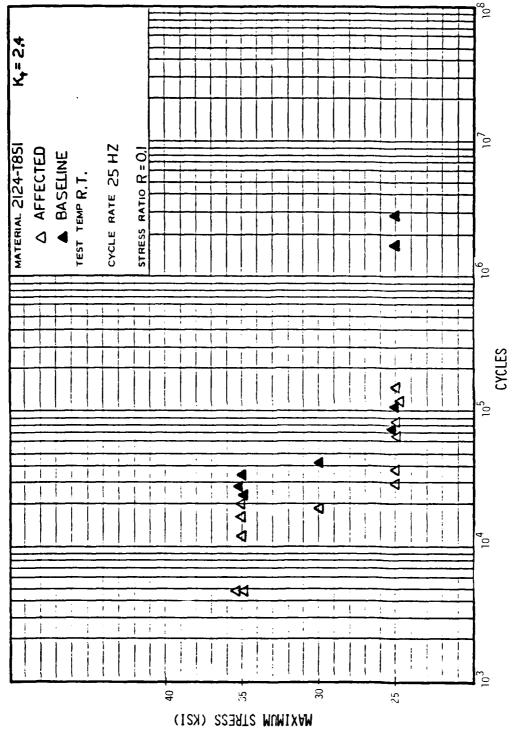
Figure 5. Smooth Fatigue Data for 2124-T851 5-1/2" Plate

Figure 5 and Table 8 document the smooth fatigue data which was generated at two stress levels. A statistical "t" test analysis of the data from the two sides of the plate indicates that there is no difference between the two sides at either of the selected stress levels. Also shown in the figure is a scatter band for literature data generated on similar material. It should be noted, however, that the smooth fatigue samples were not taken from the extremely soft location in the plate which gave the maximum reduction in tensile properties.

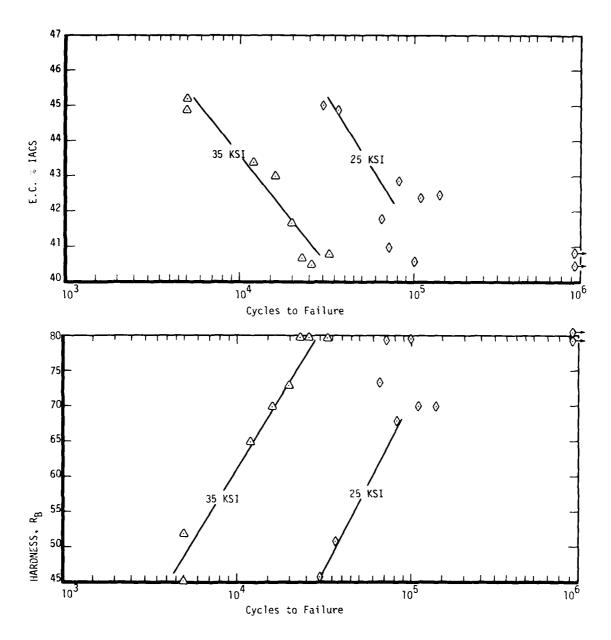
Figure 7. Notched Fatigue Data Showing Relationship Between Conductivity, Hardness, and Fatigue Life of 2124-T851 5-1/2" Plate

Notched fatigue data, which was developed from rectangular specimens with a drilled and reamed centrally located hole, is presented in Figure 6 and Table 9. A statistical "t" test analysis of these data indicate that at the higher stress level (35 KSI) the affected material has inferior properties to those of the baseline material. At the lower stress level (25 KSI) no difference in properties could be proven. The data in Figure 6 and Table 9 are plotted in Figure 7 as conductivity and hardness versus cycles-to-failure for constant maximum stress. Here there are definite trend lines, particularly at the higher stress levels, showing that the softer material has a shorter notched fatigue life.

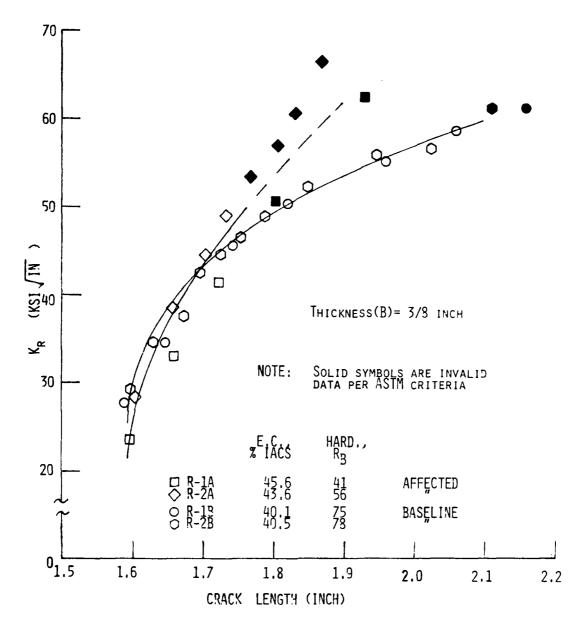
Figure 8. R-Curve Fracture Toughness Data, 2124-T851 5-1/2" Aluminum Plate

Crack growth resistance, R-curve data are shown in Figure 8. The data at the lower stress intensities, below approximately 45 KSI $\sqrt{\text{in}}$, show there is no difference between the normal and soft material. Above this point the curve for the baseline material starts to turn flat while the trend line for the affected material continues to rise. This observation is predicated on giving some credibility to the technically invalid (by ASTM E24 criteria) data for the soft material. However, it can be stated that no detrimental effects on the crack growth resistance at lower stress intensities occurred and indications are that at higher values the affected material may possess improved resistance.

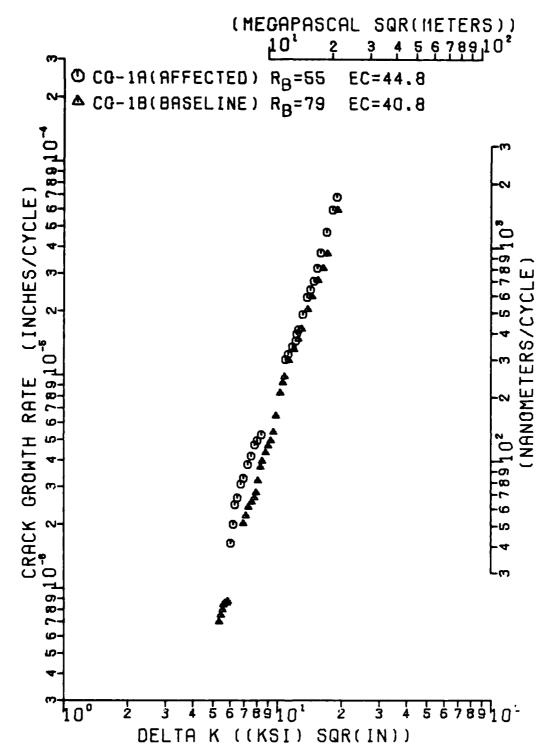
Figure 9. Fatigue Crack Growth Rate Data for 2124-T851 5-1/2" Aluminum Plate

Fatigue crack growth rate data are shown in Figures 9 and 10. In each figure the data for the affected specimen either appears slightly on the high side of the baseline data or overlaps the baseline data. However, in all cases the data are very close together. The spread in data is no more than would normally be encountered when testing two samples of exactly the same material. It can be concluded that there is very little or no effect of the softness on the fatigue crack growth rate properties over the range tested.

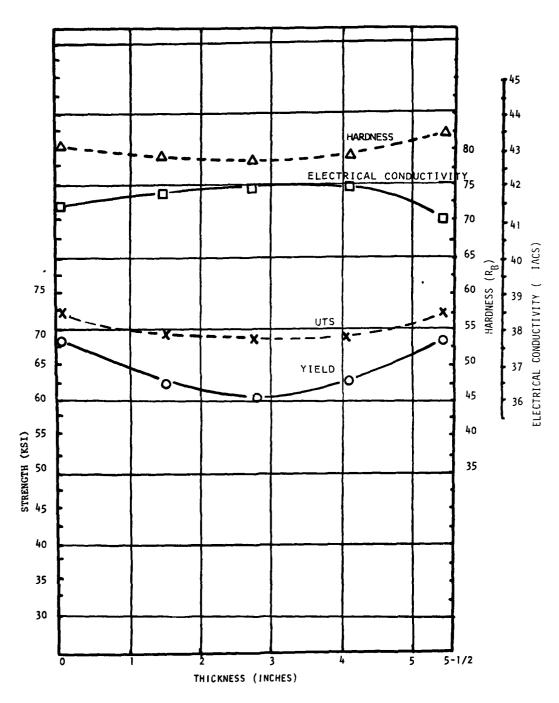
Figure 15. Tensile Data for Normal 2124-T851 Aluminum Plate 5-1/2" Thick

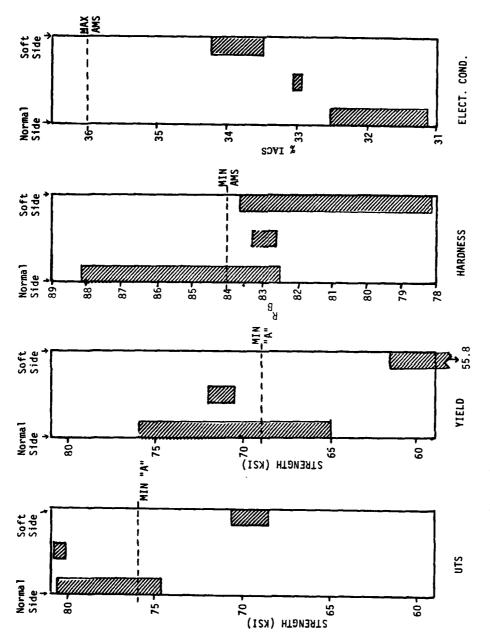
Figure 17. Effect of Slack Quench on Properties of 7075-T651 Aluminum Plate 1-1/4" Thick
